Restoration Notes

Roots of Chaparral Shrubs Still Fail to Penetrate a GeoSynthetic Landfill Liner after 16 Years

Karen D. Holl (Department of Environmental Studies at the University of California, Santa Cruz, CA 95064, kholl@ ucsc.edu) and Sean McStay (University of California Fort Ord Natural Reserve, Marina, CA 93933).

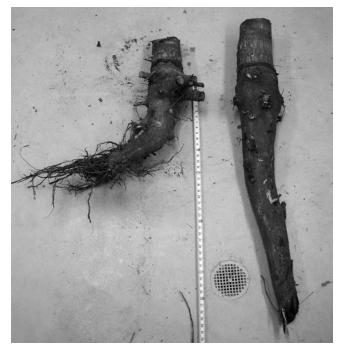
Figure 1. Taproot of ~15–cm diameter Torrey pine (*Pinus torreyana*) trees growing on (left) and off (right) a landfill liner. Note that the taproot of the tree on the liner turns abruptly left and splits into several smaller roots, whereas the taproot of the tree growing off the liner is straight. site is clearly nutrient limited (Holl 2002) and, therefore, studies are needed on more fertile soils, as coastal chaparral is found across a range from low to medium fertility (Callaway and Davis 1993, Vasey 2012).

Both Torrey pine and coast live oak have thick taproots; for example in Torrey pine the main taproot of all individuals was 8–10 cm diameter immediately below the soil surface. On the liner, the taproots of both species abruptly turned laterally ~20–40 cm below the soil surface (Figure 1) and split into several smaller roots which

occasionally reached, but did not penetrate, the liner. Off the experimental area, the tap roots grew straight down (Figure 1) and were all > 7 cm diameter at 65 cm depth (a comparable depth to the liner). Our prior excavations of shrubs off the landfill cap (Holl 2002), as well as published information (Hellmers 1955, Kummerow et al. 1977, Kummerow and Mangan 1981), suggest that most chaparral shrub roots grow at less than 60 cm depths, but that taproots of some chaparral species can extend well beyond the 60–70 cm depth of the liner when grown in deeper soils.
